Report No. UT-26.18

## UTAH SR 73 EAGLE MOUNTAIN MULE DEER CROSSWALK AND WILDLIFE- DETECTION DRIVER WARNING SYSTEM RESEARCH

Utah Department of Transportation  
Research & Innovation Division

**Final Report  
July 2026**

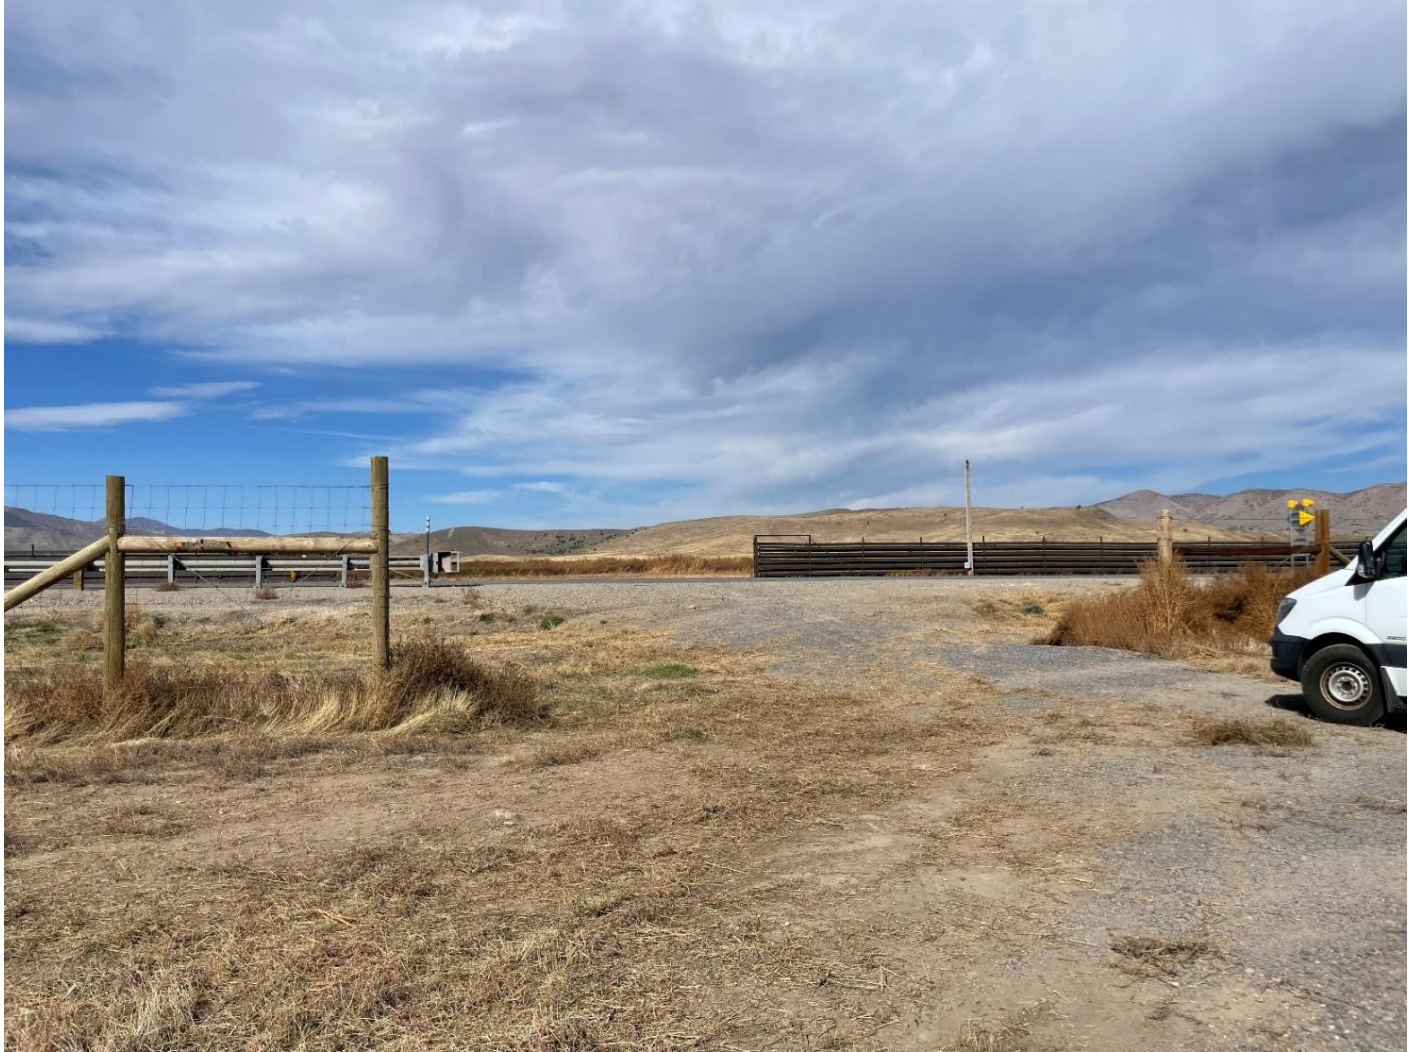
**Figure 2. The Wildlife Crosswalk across SR 73 as viewed from the South. Photo credit: P. Cramer.**

The Wildlife Crosswalk (Crosswalk) is located at Mile Post (MP) 30.35 where paired gaps in the wildlife exclusion fence allow mule deer to move across SR 73. The gap in the fence on the north side of the Crosswalk is 68 feet wide and the gap in the fence on the south side is 46 feet wide. (Figure 2).

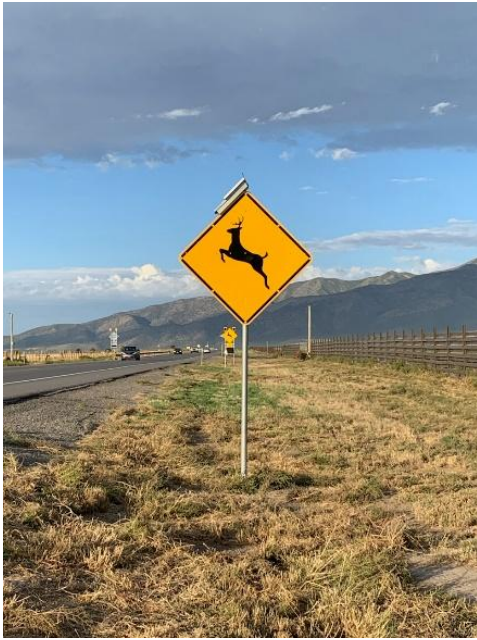
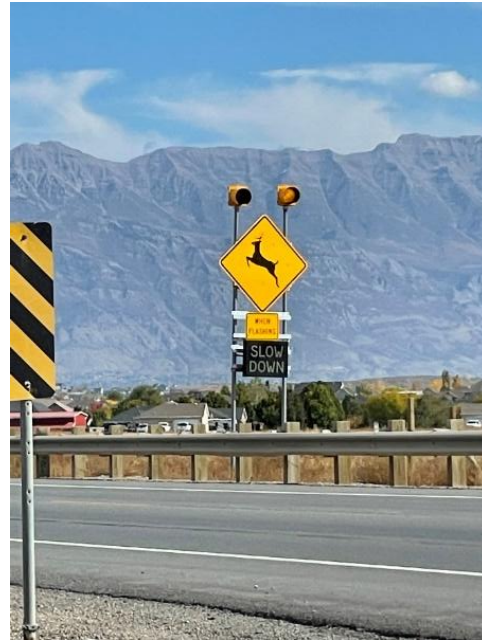
**Figure 3. Motorists were warned when approaching the Crosswalk area with yellow diamond signs with a deer silhouette on them, with small LED lights around the perimeter (A). The System signs (B) located closer to the Crosswalk were yellow diamond signs with deer silhouette, two amber flashing lights above, static signs with the words, “WHEN FLASHING,” and lighted white LED messages on black backgrounds that state “SLOW DOWN,” all of which flash when activated. Photo credits: P. Cramer.**

The Wildlife-Detection Driver Warning System (the System) was installed by CrossTek at the Wildlife Crosswalk between October 2022 and May 2023 (according to Google Earth images). The System uses infrared-camera technology to detect mule deer movements as they approach the Crosswalk gaps in the fence and then activates amber flashing lights and “SLOW DOWN” messages attached to two deer caution signs (Figure 3). The System remains activated while mule deer are being detected near the gaps or in the Crosswalk and deactivates approximately 120 seconds after detection stops. The System was the first advanced wildlife-detection driver warning system in Utah.

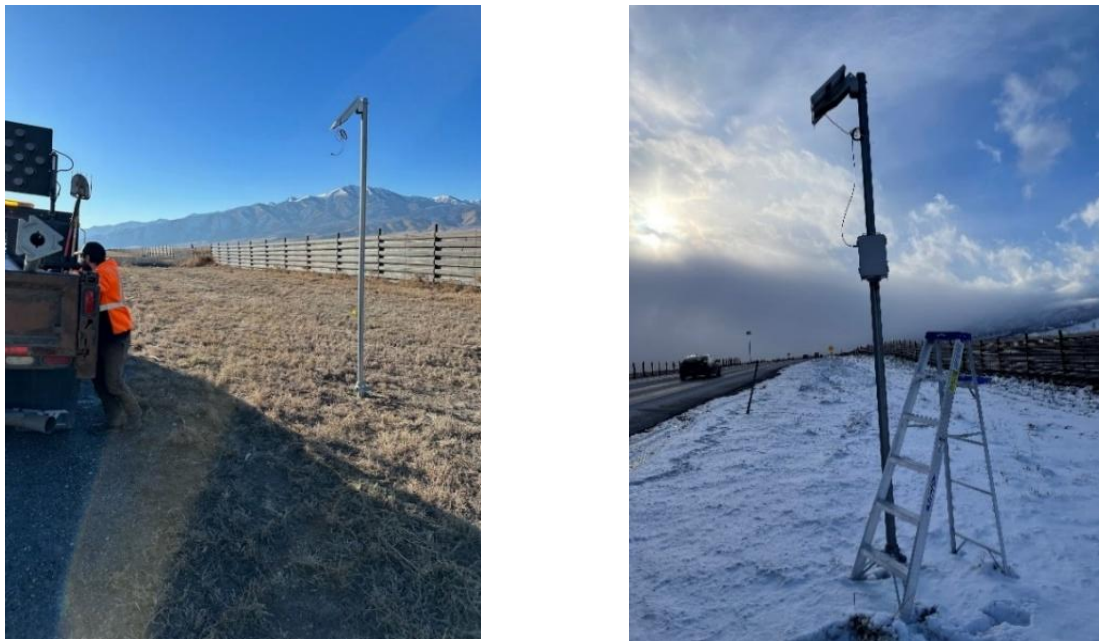
**Figure 5. Posts and solar panels installed by UDOT and Stalker, left, and Stalker Traffic Data Collectors with solar panels, right. Photo credits: UDOT and P. Cramer.**

Three Stalker Traffic Data Collectors (TDCs), posts, brackets, and solar panels were installed by UDOT Maintenance, Eagle Mountain City, and a Stalker Company representative on December 20, 2023 (Figure 5). The three TDCs were placed on the north side of SR 73 in the same east-facing orientation at the following designated locations: **West TDC** at MP 29.3, **Crosswalk TDC** at MP 30.35, and **East TDC** at MP 30.65. The three Stalker TDCs collected vehicle speeds inconsistently, were removed from the study area on March 15, 2024, and were returned to Stalker on June 12, 2024. Three new Stalker TDCs were installed with their new solar panels in the same locations on the existing three posts on November 1, 2024.

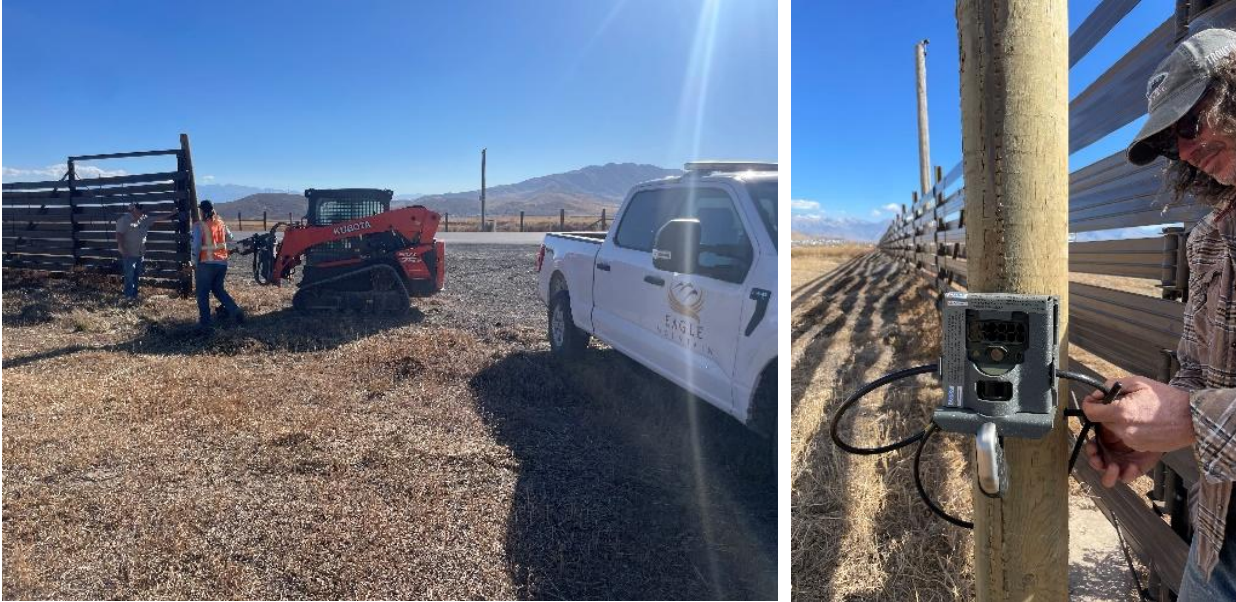
**Figure 12. Reconyx cameras were placed with the assistance of Eagle Mountain City personnel (left). Right, a monitoring camera mounted to the fence northeast pole.**

Four Reconyx Professional cameras were installed at the Wildlife Crosswalk on SR 73 at Mile Post (MP) 30.35 on November 14, 2023. Two cameras were installed at the north entrance of the Crosswalk (NW and NE Cameras) and two cameras were installed at the south entrance of the Crosswalk (SE and SW Cameras). The cameras were triggered by motion and continuously recorded mule deer movements with the following Reconyx settings: five photographs per trigger, no delay, and nighttime maximum range (Figure 12). The cameras were checked on November 20, December 5, 2023, January 8, March 15, June 12, October 27, 2024, and February 6, 2025, at which time the cameras were pulled. All photographs and videos were downloaded, stored, and analyzed.

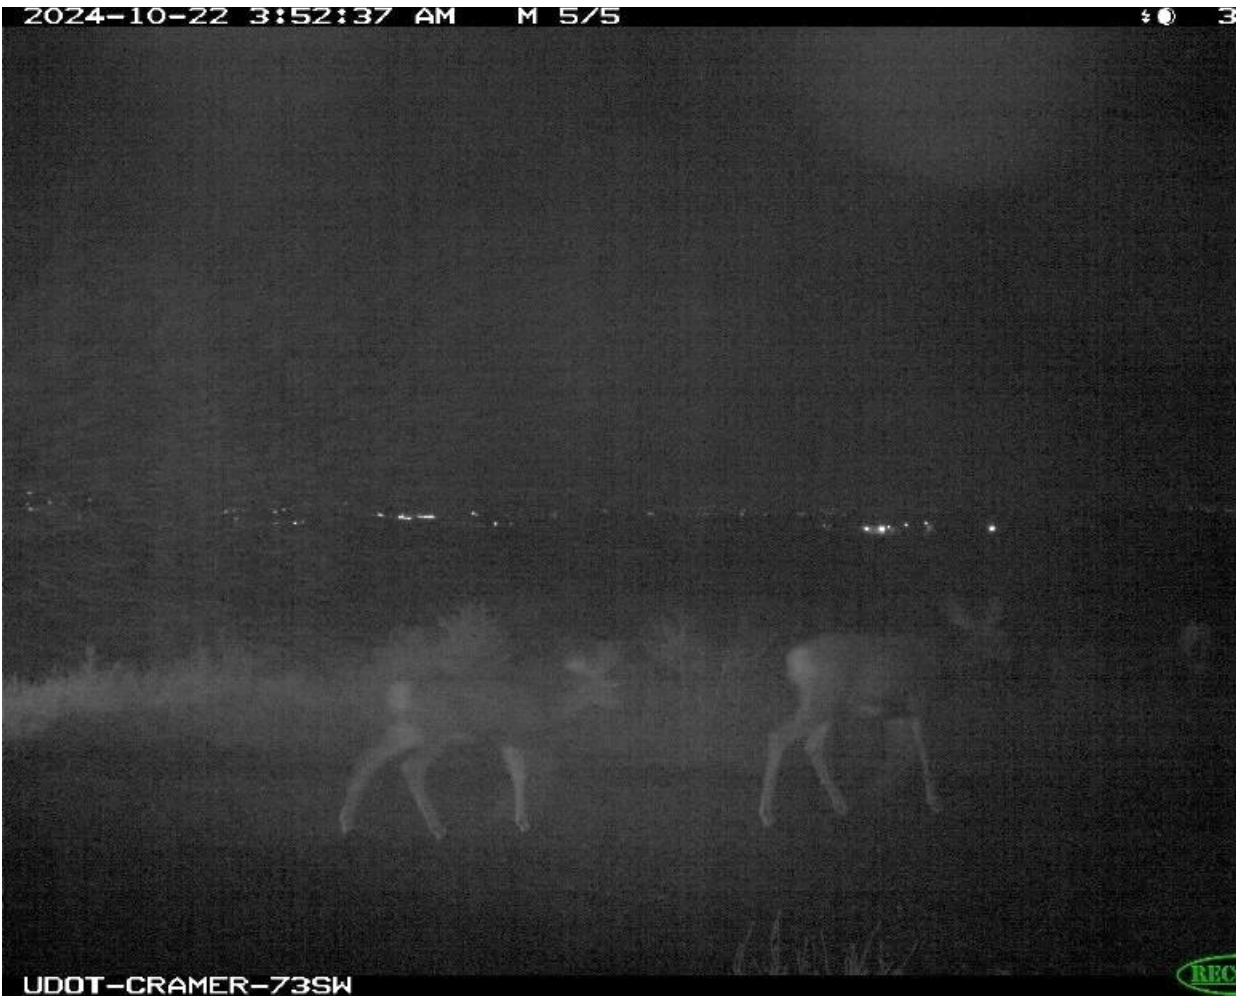
Figure 14. Example of mule deer photographed with the glow of the System warning lights.

Illumination from the Wildlife Detection System's amber warning lights was observed on the landscape in nighttime photographs recorded by the NW, NE, and SW Reconyx Cameras (Figure 14) during 1,485 of 1,584 nighttime individual mule deer movements (94 percent). There were no observed delays in the nighttime illumination of the System's warning lights as mule deer approached the Crosswalk. The duration of the System's warning appeared appropriate; the warning lights remained illuminated during most nighttime mule-deer success movements. On many occasions, these success movements lasted more than five minutes with numerous false starts as mule deer negotiated the Crosswalk, and in most instances, the System's warning lights remained illuminated.
